CAUSE, PREVENTION, AND REPAIR OF LONGITUDINAL SHEAR CRACKING

We recently had the opportunity to visit and study in detail a project that experienced this cracking phenomenon. The pavement in question was a curved section of ramp ("flyover"-type design) from one interstate highway to another. In this case, we were provided the following design and construction information:

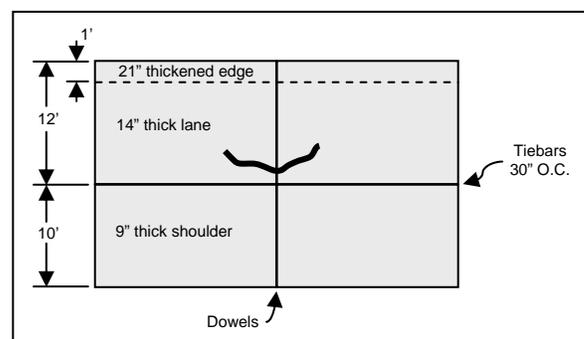
Figure 1. Typical crack pattern.

At the time of the initial survey on (June 2004), there were approximately 15 joints with cracks radiating from each side of the joint toward the centers of the adjacent slabs as shown in Figures 1 and 2.

The cracking type as shown in Figure 2 is a longitudinal shear cracking pattern. It is caused by restraint at the transverse joints – the open transverse joints are not allowed to close as the concrete expands during warm weather, and the cracks start at the transverse joint and curve toward the center of the slab.

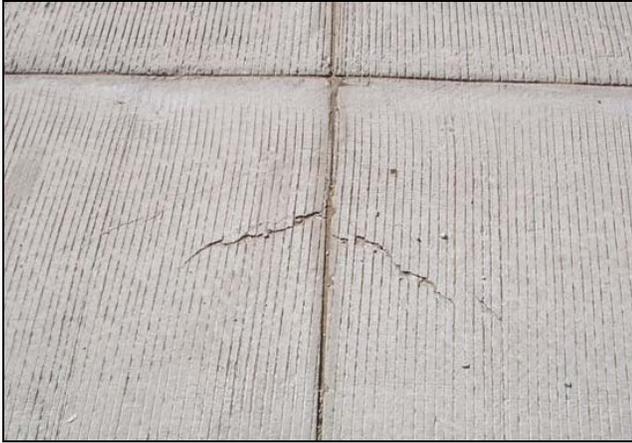
Figure 2. Photo of actual crack pattern from subject project. (NOTE: photo taken looking from driving lane toward shoulder).

The exact location where the cracks occur depends on where the highest stress concentration may occur. This may be over the first dowel bar, or at some other location near the corner. On the subject project visited for this report, the cracks occurred at various distances away from the corner of the slab. This distance was somewhat proportional to the superelevation of the ramp pavement. Cores taken at the affected transverse joints showed mortar intrusion into the joints in the first placement from the adjacent shoulder placement. The mortar flowed further into the joint when superelevation was greatest.

In most cases, full-depth repairs (full-lane wide) to a point at least six inches beyond the extent of the cracking are appropriate to repair the affected areas. The entire slab on either side of the joint need not be replaced, since the expansion has already taken place and the full-depth repair will allow for two joints instead of one to accommodate for future movement.

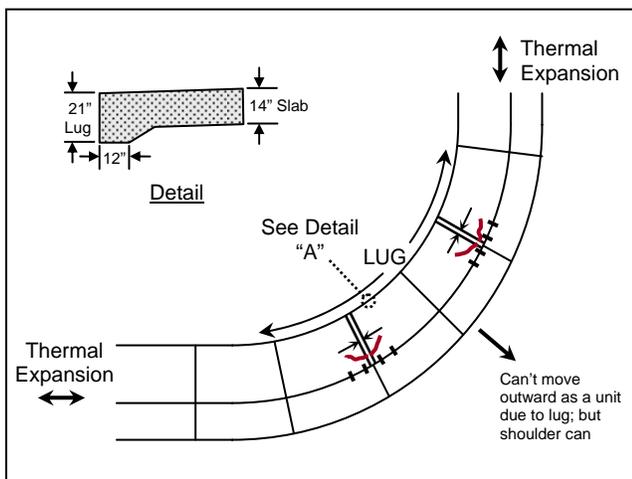
1. The different ambient temperatures during the placement of the two adjacent pavement sections likely resulted in different equilibrium temperatures for the in-place concrete. This means that the concrete placed and cured at a lower temperature (the 10-ft shoulder in this case) will expand more when temperatures rise than the other concrete (the 12-ft lane), which was cured at a higher temperature initially. The mean monthly temperature in this area for September 2003 was 72°F and 42°F for January 2004.
2. The thickened longitudinal edge (lug), in combination with the high-friction base under the 12-ft lane, restrained the pavement and resulted in every 4th joint working, instead of every joint (i.e., not every joint “popped” right away). This is common on almost every concrete pavement, but can be aggravated by high-strength (high-friction) bases and thicker

3. The granular base under the shoulder provides much less friction and allows more slab movement, therefore more working joints in the shoulder pavement.

4. The horizontal curve may be adding to the stress build-up because the lug and high-friction base combination likely prevents outward movement of the entire roadway during thermal expansion. The restraint would be most pronounced at the center of the curve (where most of the cracks have occurred), because the tangent roadways from either end of the curve are expanding and trying to push the curved pavement outward.

5. The tiebars along the lane/shoulder joint also may be locking the corners of the slab, preventing the opened joints in the 12-ft lane from effectively closing.

6. Mortar intrusion into the transverse joints from the separate shoulder placement operation influenced the location of where the crack occurred, if not being a direct causal factor.

Figure 3. Schematic of factors leading to cracking.

1. Use caution when a longitudinal thickened edge (“lug”) is specified. Determine whether it is an essential part of the design or could be eliminated through tapering the thickness (1 to 2 inches for example) across the entire slab, or by simply providing a tied connection to the existing pavement.

2. When constructing pavements on high-friction bases such as cement-treated, asphalt-treated, or econcrete, be aware that not every joint will crack (“pop”) right away. This might result in wide joint widths for those joints that do pop. These wide joints will eventually close, however, when the temperature increases in the summer. You can ensure cracks form at joints on a closer interval by reducing the friction at the slab/base interface with a coat of curing compound, or by broadcasting a thin layer of fine sand across the base.

3. Adjacent pavements on different base types will have different movement capabilities and capacities with the same change in temperature. As much as possible, try to use bases with similar characteristics under adjacent slabs. NOTE: Concrete pavement thickness design is not very sensitive to base type, so the cost savings in specifying lower quality base types under non-trafficked areas like shoulders is not cost effective when you factor in the expense of constructing two different base types adjacent to each other.

6. Eliminate one or two tiebars in the longitudinal joint near the locations of transverse joints to reduce the potential for locking the corners of the slab. Many longitudinal joint designs are already over-reinforced with tiebars anyway – the assumptions and theories behind tiebar design/spacing are suspect and plans are underway by ACPA to determine new tiebar design methods.

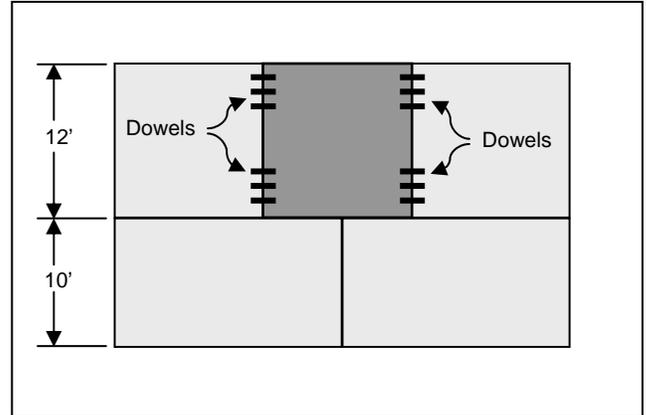
Figure 3. Full-depth repair details.

Make sure to utilize full-depth sawcuts around the entire perimeter of the area to be repaired, and drill and grout dowel bars into the adjacent slabs (see Figure 4). Do not use tiebars along the longitudinal joint. For more information on full-depth repairs, consult ACPA publication TB002P, “Guidelines for Full-Depth Repair.”
