## CONCRETE MIXES AND PAVEMENT CONSTRUCTION FOR AIRCRAFT DEICING FACILITIES

*NOTE: This R&T Update summarizes an Innovative Pavement Research Foundation (IPRF) research project funded by the Federal Aviation Administration (FAA). The text in this R&T Update was extracted from report # IPRF-01-G-002-03-3 by Van Dam, et. al.*

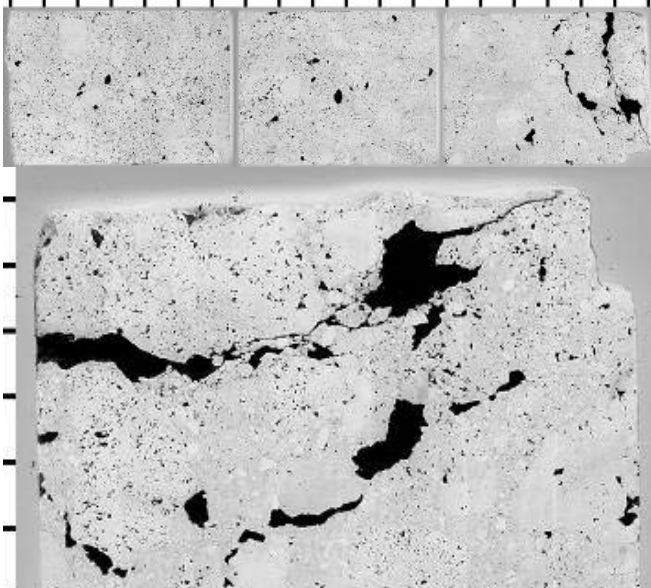
Two cores from Airport A exhibited large interconnected pores close to the surface (Figure 3 on next page), indicative of poor construction practice (i.e. poor consolidation and excessive bleeding), and an assured catalyst for the ingress of deicer and subsequent freeze-thaw damage. Airport A was also the only site where a supplementary cementitious material was not used. In the absence of supplementary cementitious materials, higher quantities of calcium hydroxide would be expected in the hydrated cement paste. An abundance of secondary calcium hydroxide deposits suggests leaching of calcium hydroxide in the cement paste and re-deposition in the entrained air voids, a phenomenon made possible by the increased permeability associated with the highest w/c ratio of any site.

**Figure 3: Polished Slab from Core C at Airport A (tick marks every 2 cm) and a Close Up at the Pavement Surface (tick marks every cm)**
